LEVEL 3

# Your survey report

Inspection Date

7th March 2025

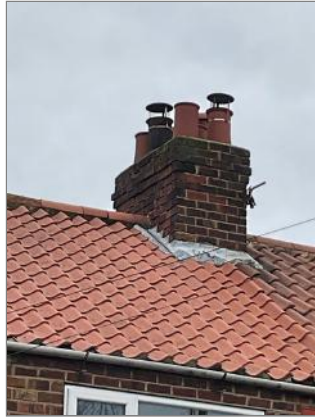
The jointing between the bricks is in a poor condition. The defective areas should be renewed.

*Photo - 4 Defective pointing*

You should instruct a competent contractor with a safe means of access to provide a quotation prior to exchange.

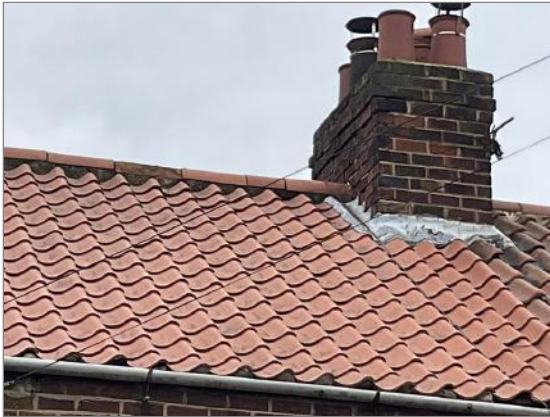
We note that the ridge tiles are frost damaged and selective replacing is required. Mortar pointing to the eaves is cracked and missing in places, requiring repointing. The pointing to the ridge tiles is weathered to several locations, requiring repointing.

*Photo - 5 Ridge - frost damage*

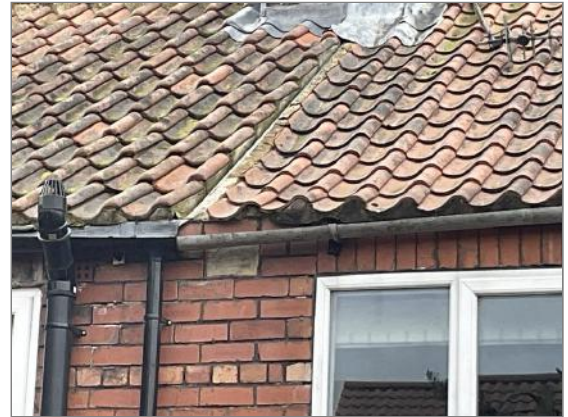
*Photo - 6 Eaves - Defective pointing*

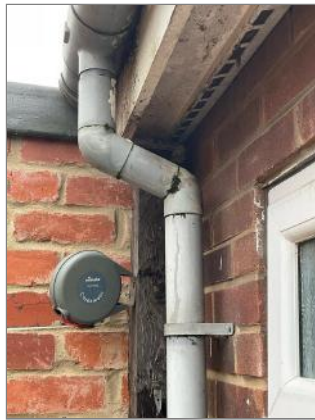
The PVC rainwater goods are of considerable age and significantly stained, presumably due to long term minor leakages, beginning to discolour (solar degraded) and additionally are now likely to be brittle. Some sections are mis-aligned, and the rubber seals are likely beginning to perish, which will lead to leaking from the joints particularly at corners. In the first instance a minor overhaul and a thorough clean is required, checking that they are free from moss and obstruction. However, some sections will need replacing and you may consider it prudent to completely upgrade the rainwater goods. During our inspection defects were identified as follows: sagging gutters and leaking joints.

*Photo - 7 Rainwater goods - defective joints*

These defects can lead to the impaired function of the rainwater disposal system resulting in dampness internally and other external deterioration. The system now requires a thorough overhaul to leave it sound and watertight. You may wish to instruct a competent contractor to provide an estimate for these works and any necessary associated repairs. We recommend that the works are undertaken as soon as possible.

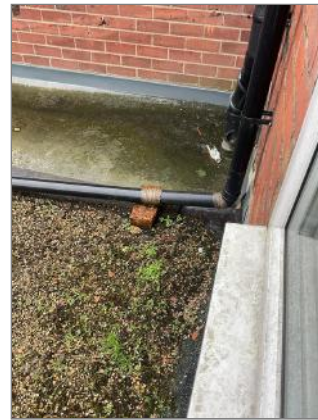
*Photo - 8 Rainwater goods - defective joints*

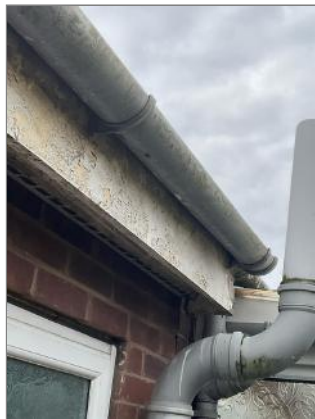
The external decorative finishes are in poor condition and at least redecoration is required. However, you should budget for some timber replacement as rot is likely to be identified on closer inspection.

*Photo - 9 Decorations - Defective*

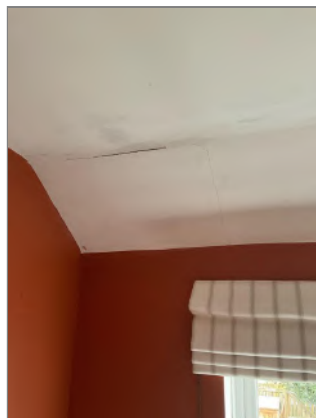
*Photo - 10 Loose ceiling repair*

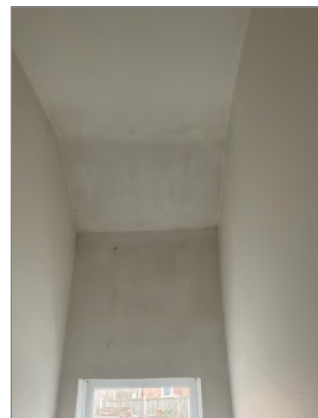
*Photo - 11 Ceilings - Condensation & mould*

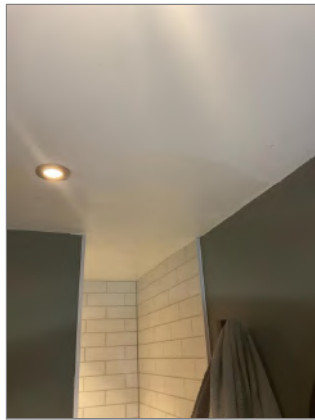
*Photo - 12 Ceilings - Condensation*

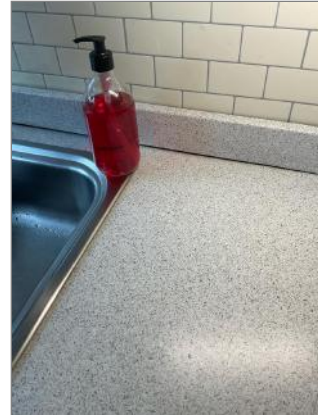
*Photo - 15 Missing mastic joints*

All silicone seals to kitchen fixtures should be maintained in a good condition to prevent the penetration of water and the associated risks to adjacent timbers.
