LEVEL 3

# Your survey report

Inspection Date

7th March 2025

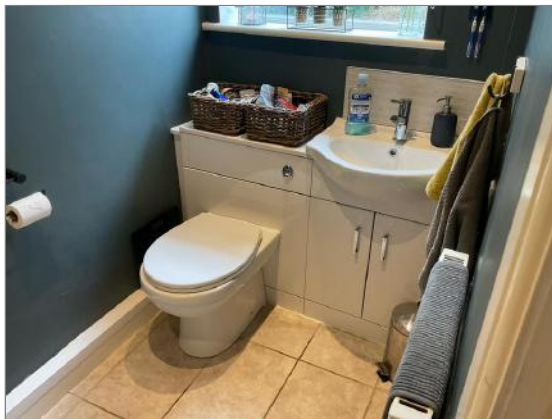
*Photo - 16 Sanitaryware*

Be aware that when a shower is located within a bathroom or shower room, wear and tear is inevitable to the shower tray particularly. Leaks often occur which may not be readily apparent. Showers and shower trays should be regularly checked and repairs will undoubtedly be required from time to time. By their very nature showers generate significant amounts of steam which will in turn cause condensation. Even with a good mechanical ventilation system mould can be problematic and you will need to remain vigilant and take action at its onset.

Scratched or chipped surfaces to sanitary fittings can be repaired by specialist contractors using proprietary techniques with the fitting still in place. You should use an appropriately qualified person to do this.

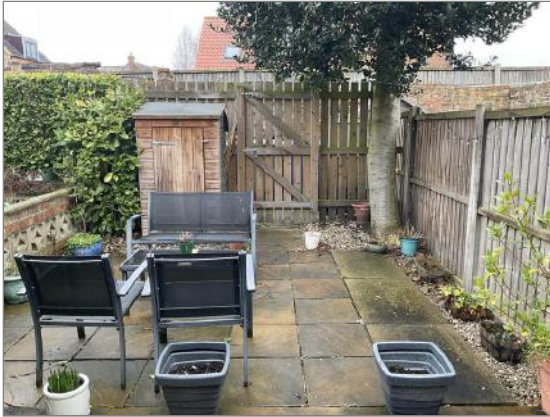
*Photo - 17 The rear garden*

The grounds appear in a satisfactory condition, usual maintenance, pruning, cutting, digging of the elements of the garden should be carried out on a regular basis.
