Your survey report

Inspection Date 19th May 2025

About the inspection and report

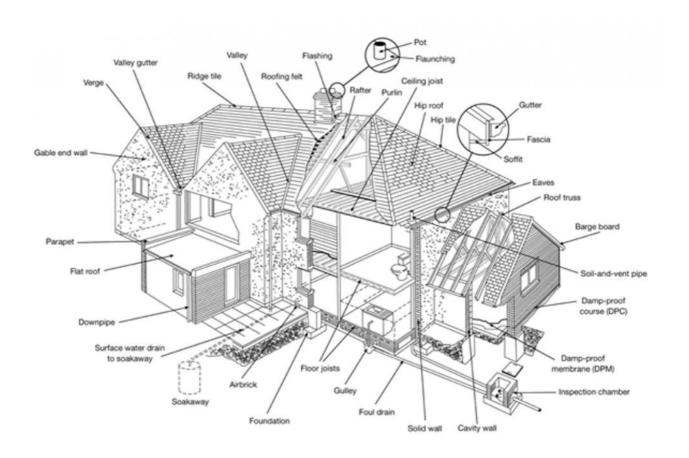
Typical house diagram

This diagram illustrates where you may find some of the building elements referred to in the report.
